# 737 GRAPHITE COMPOSITE FLIGHT SPOILER FLIGHT SERVICE EVALUATION

SEVENTH ANNUAL REPORT  
MAY 1980 THROUGH APRIL 1981

Prepared under Contract NAS1-11668 by  
BOEING COMMERCIAL AIRPLANE COMPANY  
FEBRUARY 1982

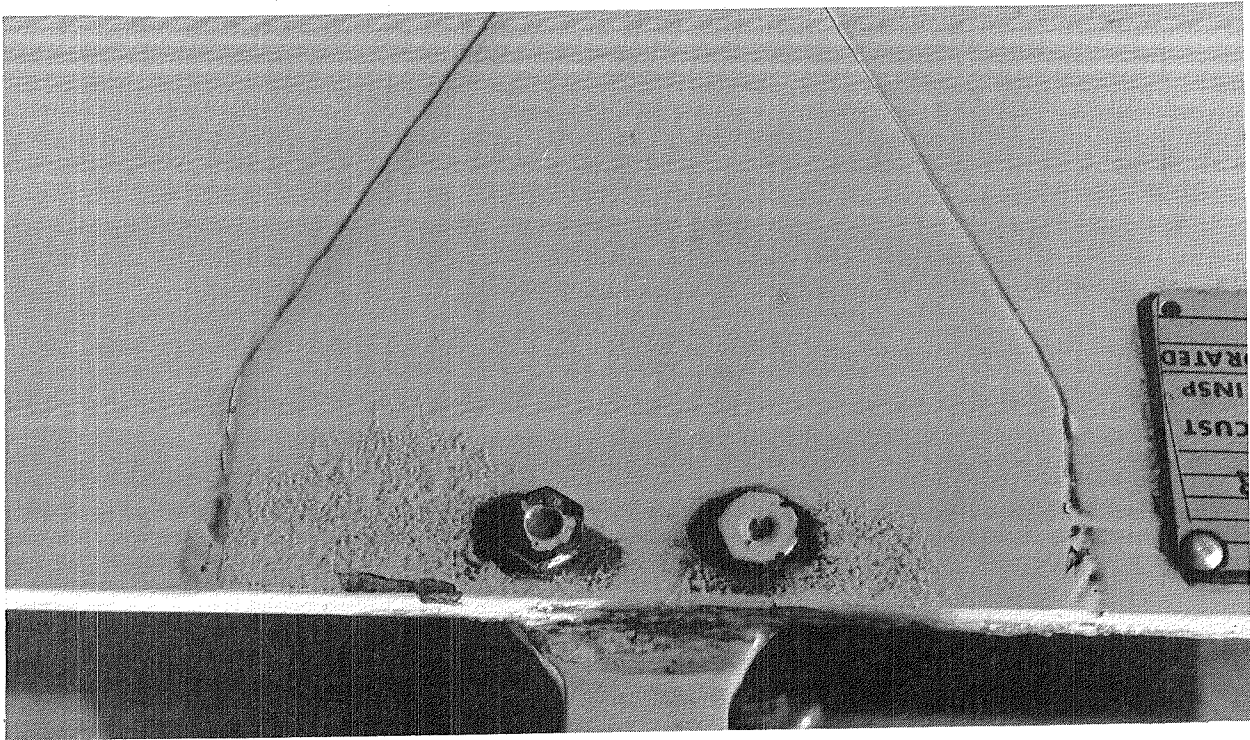
Following selection for test, the units were photographed. Figures 2 and 3 show the upper and lower surface of spoiler S/N 0059. The discrepancies on this unit are shown in figures 4 through 6. Figure 4 shows some minor corrosion of one of the -23 aluminum doublers. Figure 5 shows an exfoliation corrosion blister at one spar to center hinge fitting splice, and figure 6 shows a similar exfoliation corrosion blister at the opposite side.

*Figure 4. Minor Doubler Corrosion on S/N 0059*

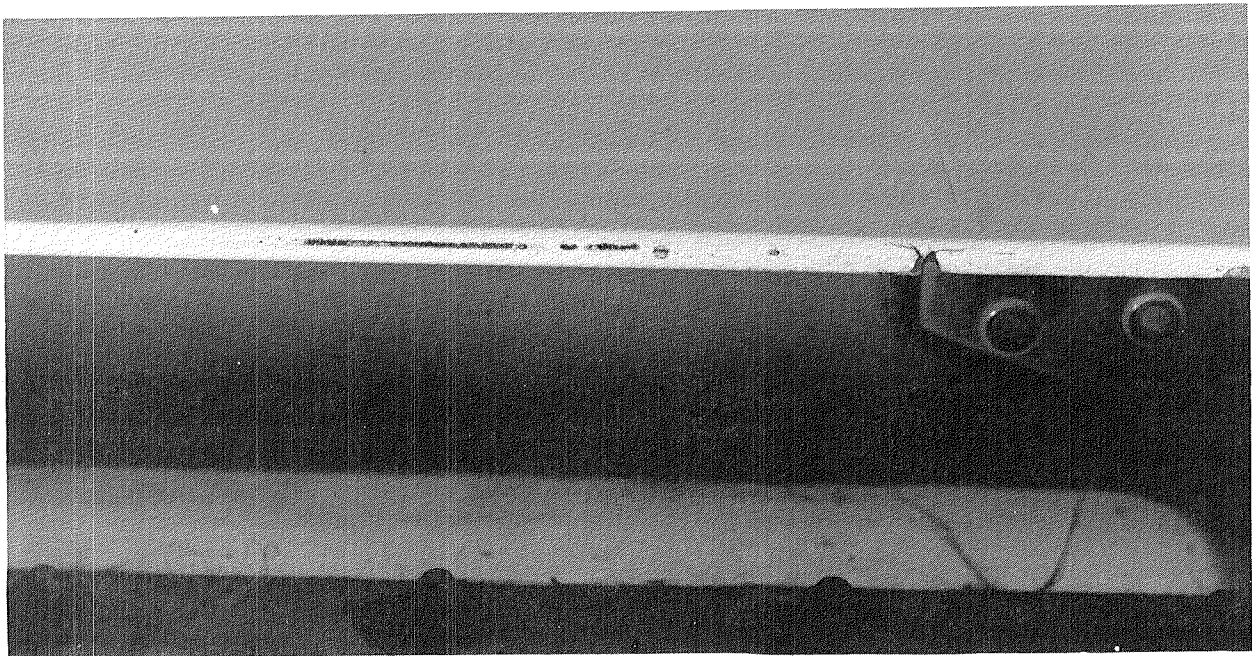
*Figure 5. Exfoliation Corrosion at Outboard Spar to Center Hinge Fitting Splice on S/N 0059*

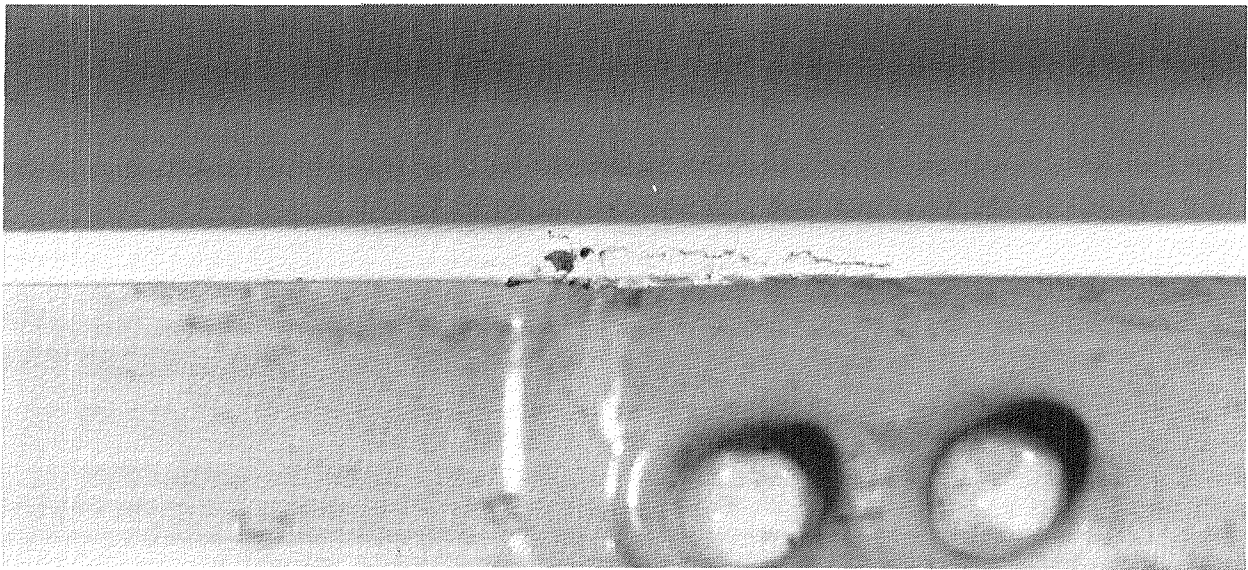
Figures 7 and 8 are photographs of the upper and lower surfaces, respectively, of spoiler S/N 0049. Earlier minor doubler corrosion and flap rubbing had been dressed down and repainted by the airline. Discrepancies for this unit are shown in figures 9 through 12. Figure 9 shows an edge crack resulting from an exfoliation corrosion condition from the outboard spar to center hinge fitting splice. Figures 10 through 12 show the opposite splice in detail. The area had undergone a repair for exfoliation corrosion, but the problem redeveloped during additional service. The repair finish is relatively coarse, because this is not an aerodynamic surface. Figures 11 and 12 show in detail the corrosion blister and edge crack.

*Figure 9. Exfoliation Corrosion at Outboard Spar to Center Hinge Fitting Splice on S/N 0049*

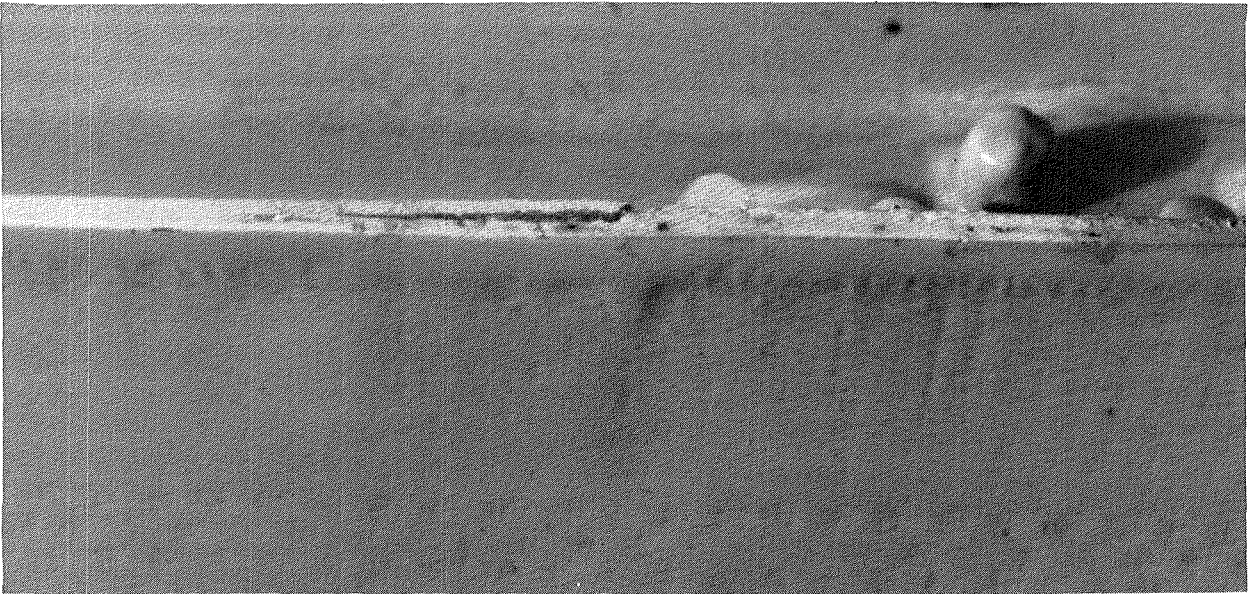
*Figure 11. Exfoliation Corrosion at Inboard Spar to Center Hinge Fitting Splice on S/N 0049*

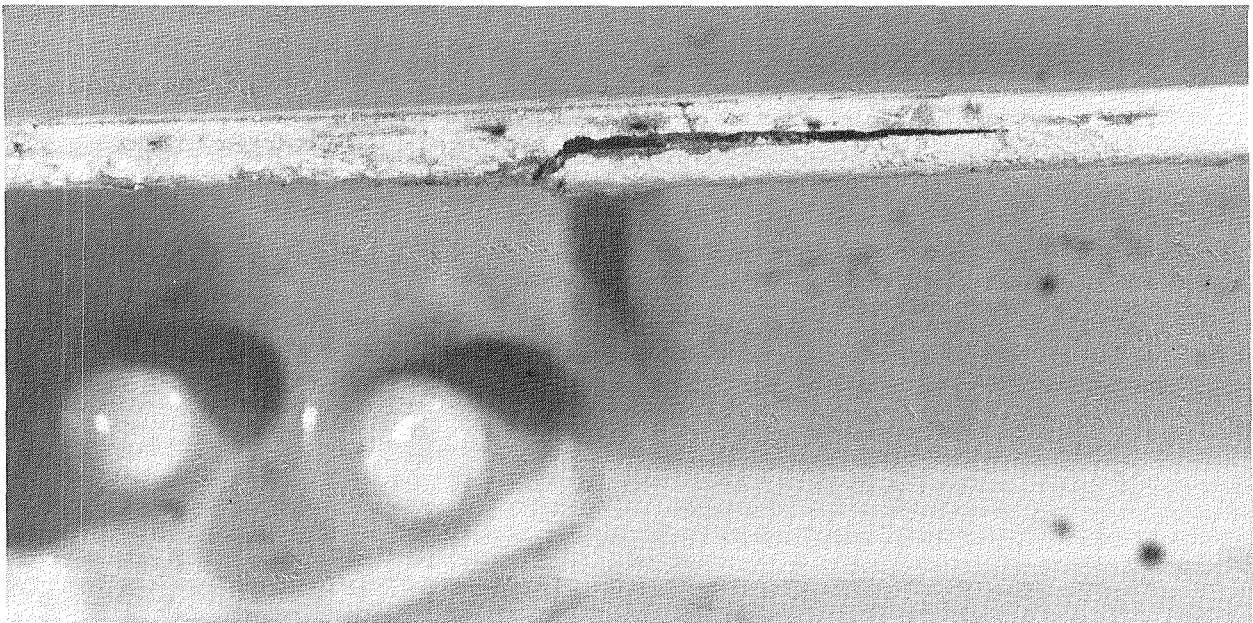
*Figure 12. Exfoliation Corrosion at Inboard Spar to Center Hinge Fitting Splice on S/N 0049*

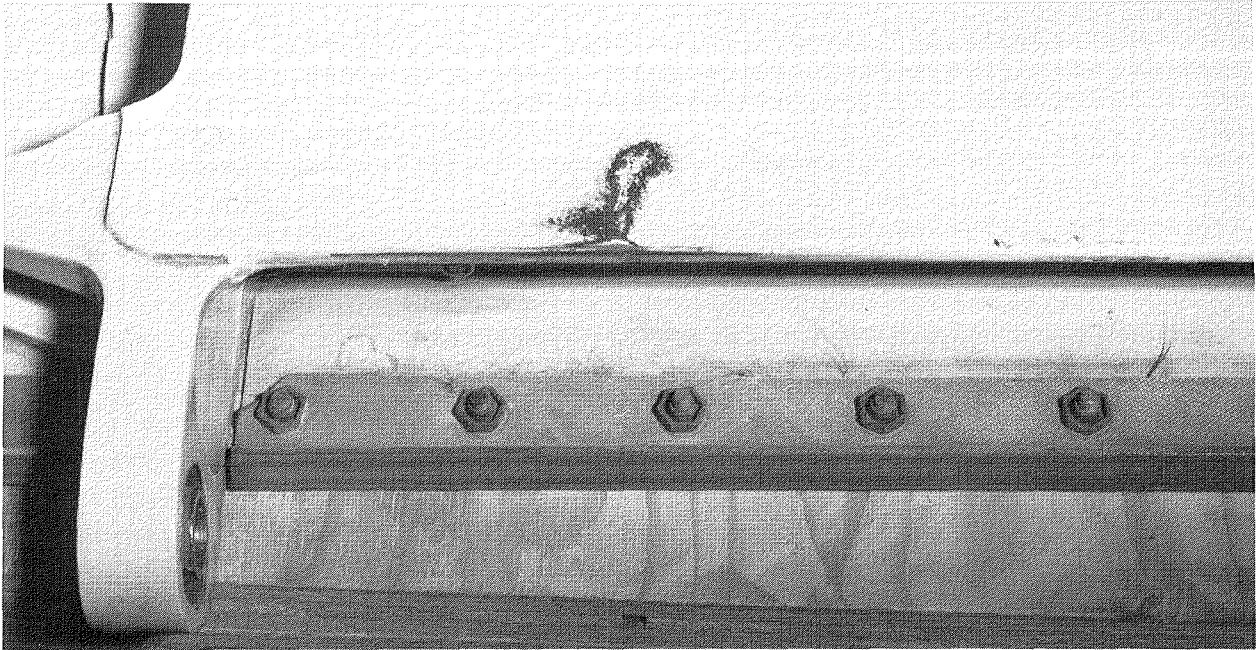
Figures 17 through 27 are photographs of the spoiler panels after testing. On both units, the exfoliation corrosion blisters locate the failure by allowing the compression-loaded lower skin to buckle at the blister location. As expected, these defects did not significantly reduce residual panel strength or stiffness.

*Figure 19. Detail at Exfoliation Corrosion Location of Spoiler S/N 0059 Following Residual Strength Test*

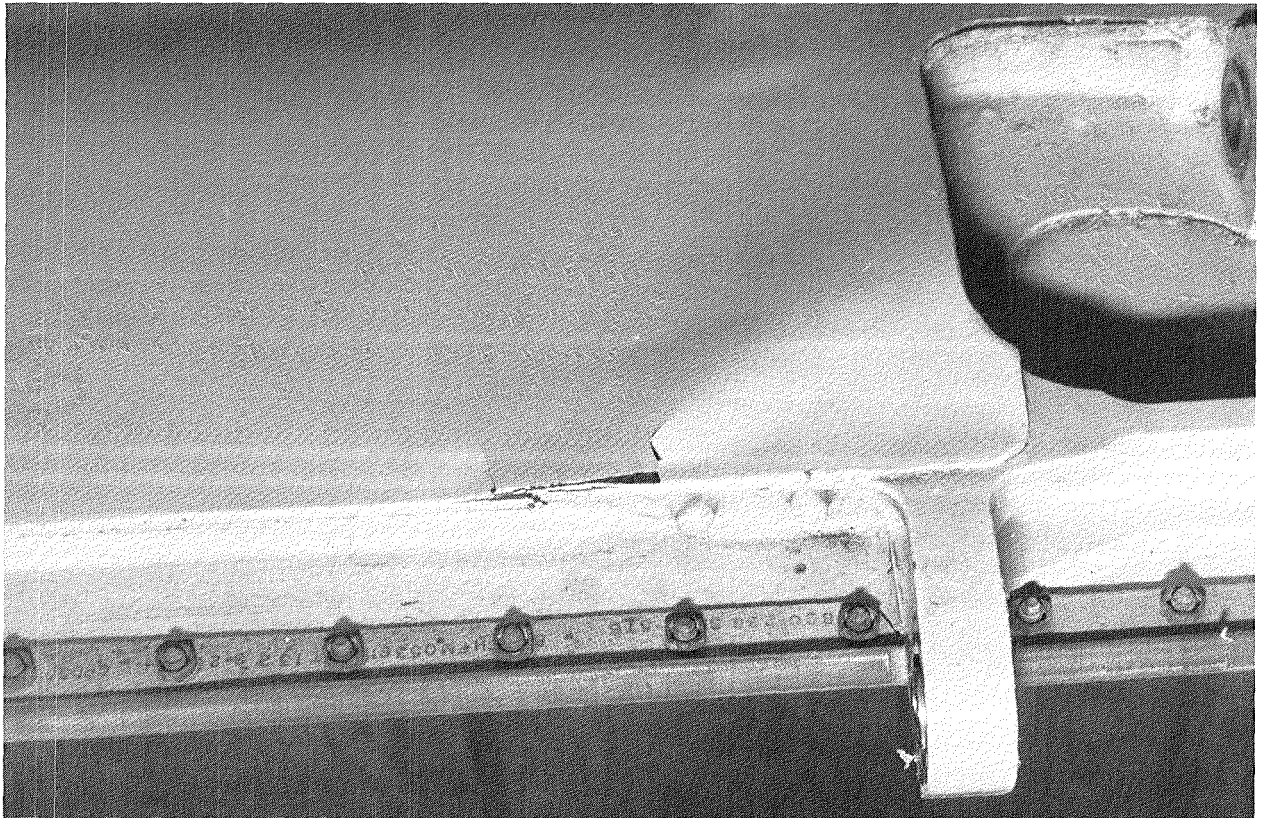
*Figure 25. Lower Surface Detail at Exfoliation Corrosion Location of Spoiler S/N 0049 Following Residual Strength Test*

*Figure 26. Lower Surface Detail at Exfoliation Corrosion Location of Spoiler S/N 0049 Following Residual Strength Test*

*Figure 27. Lower Surface Detail at Exfoliation Corrosion Location of Spoiler S/N 0049 Following Residual Strength Test*

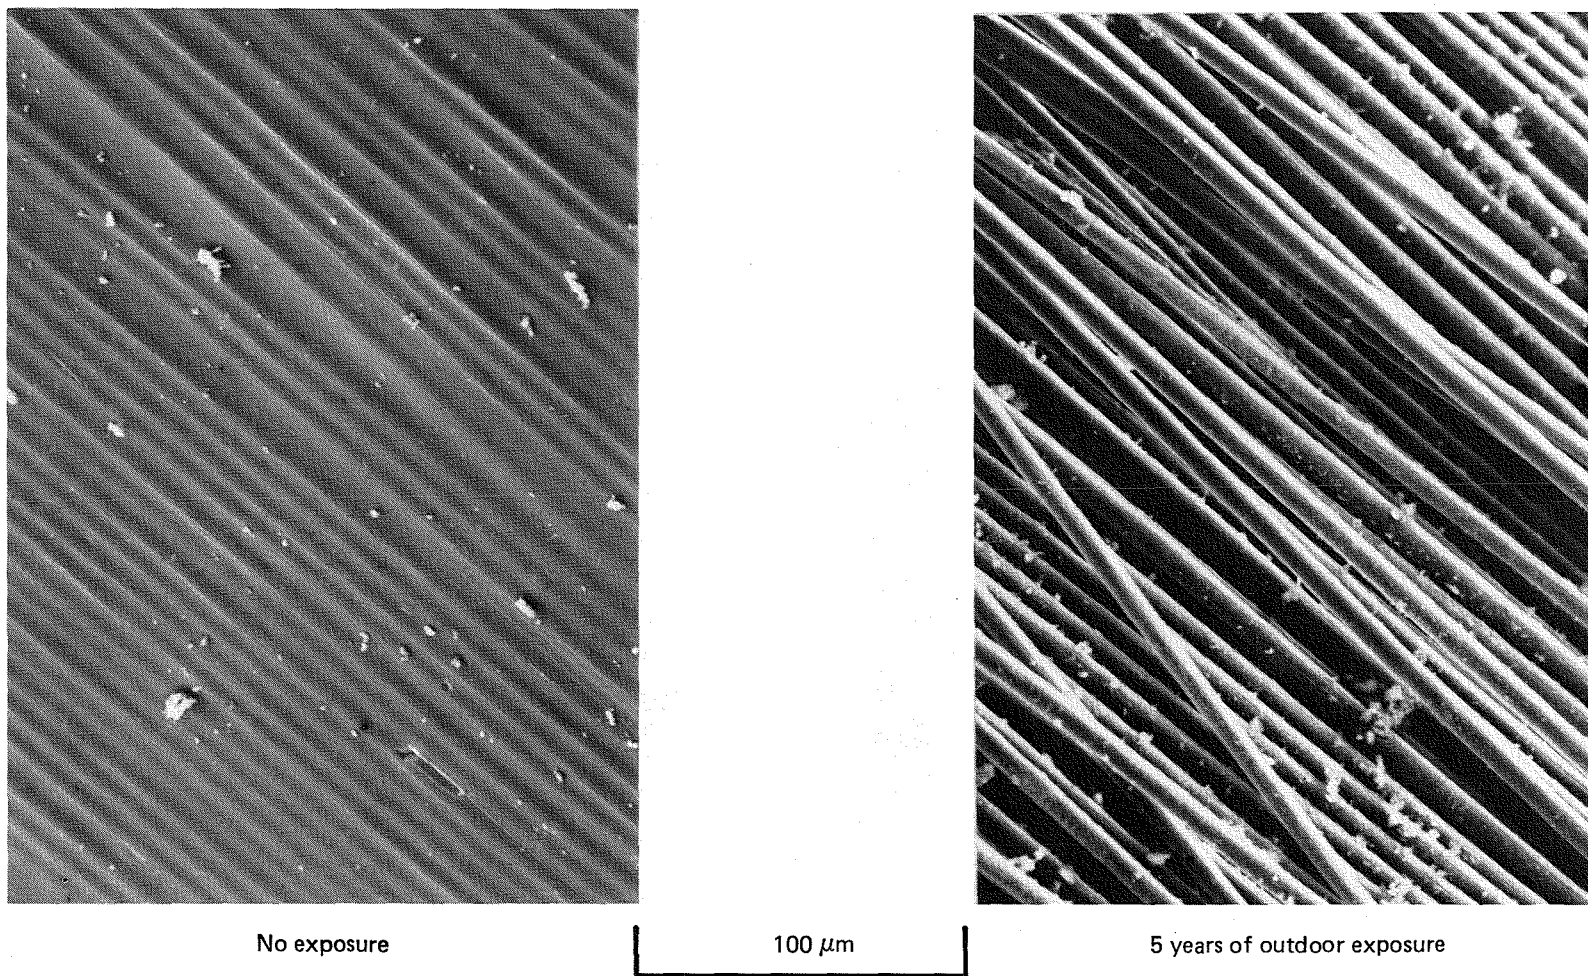
Ultraviolet radiation can change the chemical structure of epoxy and, therefore, has a degrading effect on the matrix of fiber-reinforced epoxy laminates. Photographs were made of three specimens representing each of the material systems as shown in figure 28. A comparison of the three indicates that T300-2544 is most susceptible to the degrading effect of ultraviolet exposure. The degradation is, however, superficial and does not appear to affect the strength of the material. To observe this effect more closely, a scanning electron microscope was used to photograph an AS-3501 specimen, shown in figure 29. The photomicrographs compare a specimen with no exposure with a specimen with 5 years of exposure. The individual fibers can be seen in the 5-year specimen after the surface layer of epoxy was leached away. It should be noted that a coating of polyurethane aircraft paint will protect the material from ultraviolet degradation.

*Figure 29. Surface Degradation of AS-3501 Graphite-Epoxy*
